GILMORE & ASSOCIATES, INC.
Engineering & Consulting Services

December 21, 2005

File No. 05-348

Reference: Parker Ford Manufacturing Facility – Eco Paver Infiltration Test Investigation
East Coventry Township, Chester County, Pennsylvania

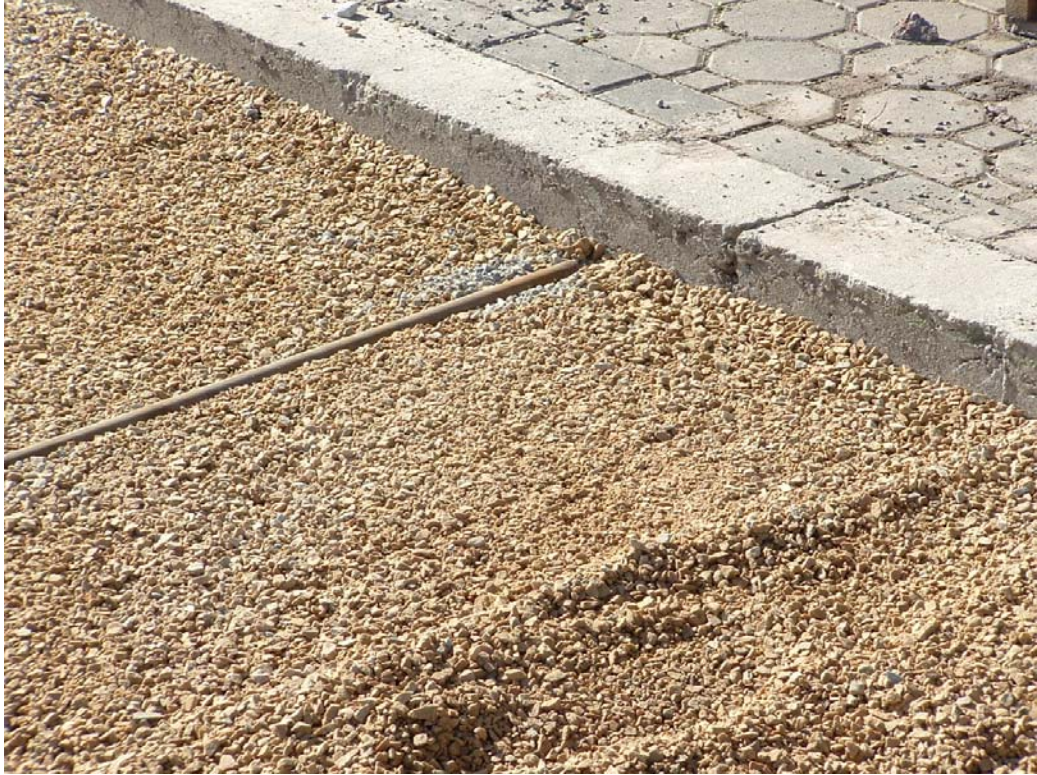
1

Eco Paver
pea gravel
leveling pad

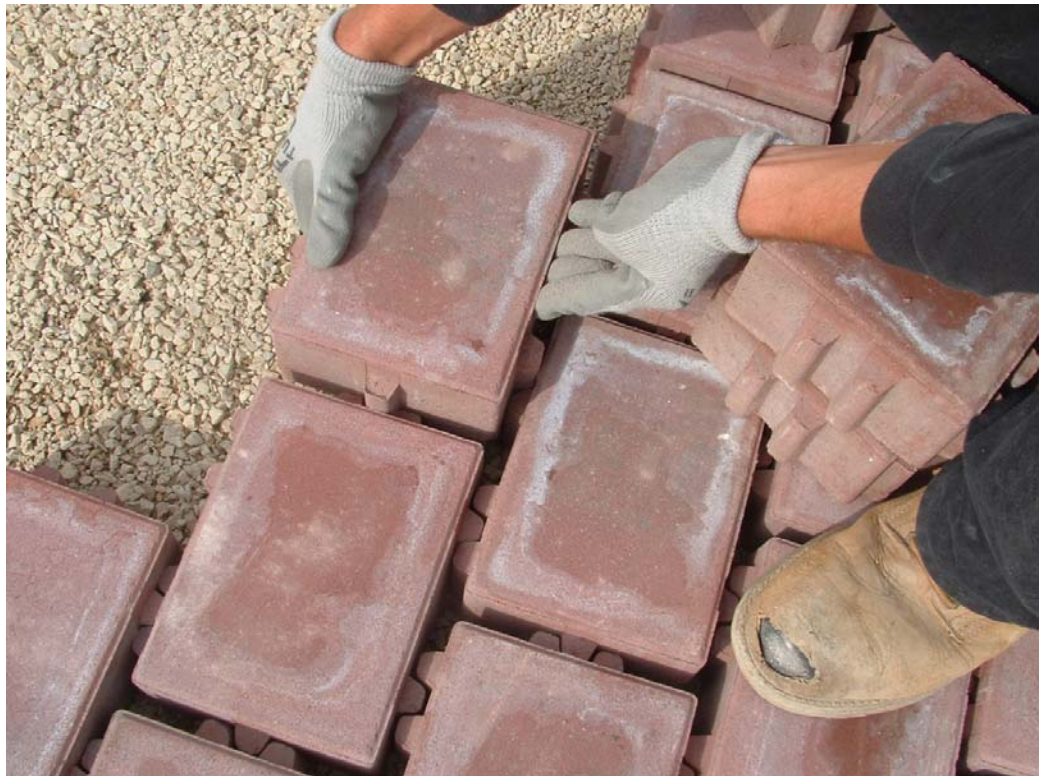
2

Eco Paver
installation
over pea
gravel
utilizing
interlocking
fingers

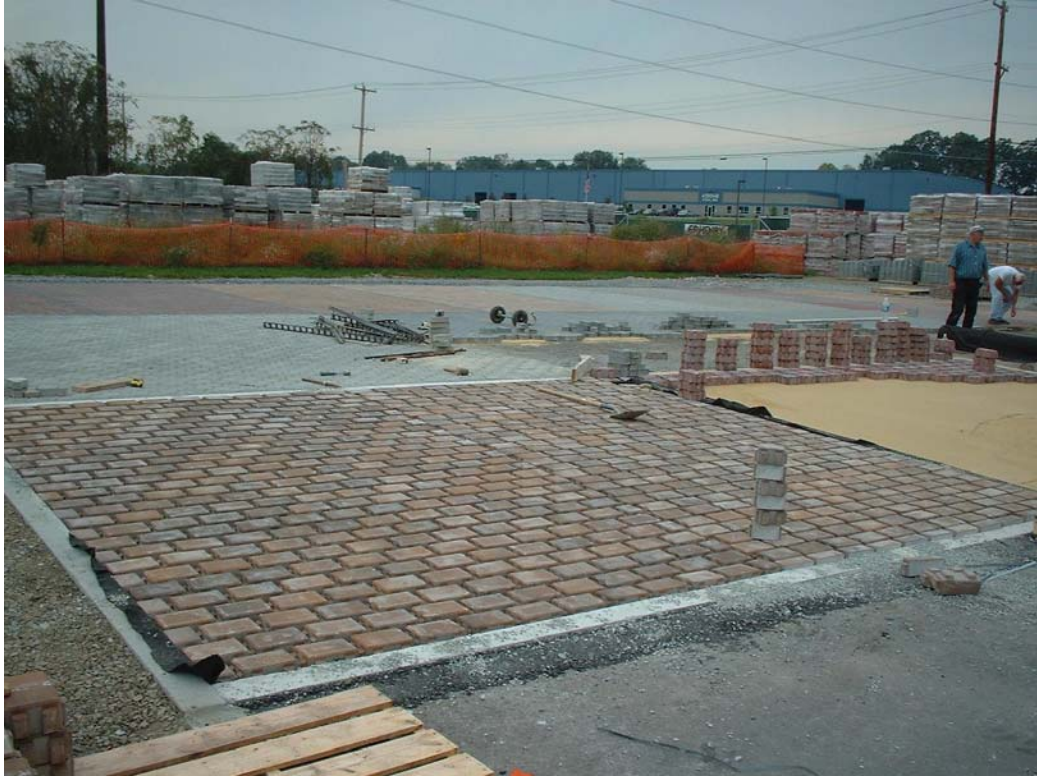
3

2A stone
subbase Eco
Paver pad

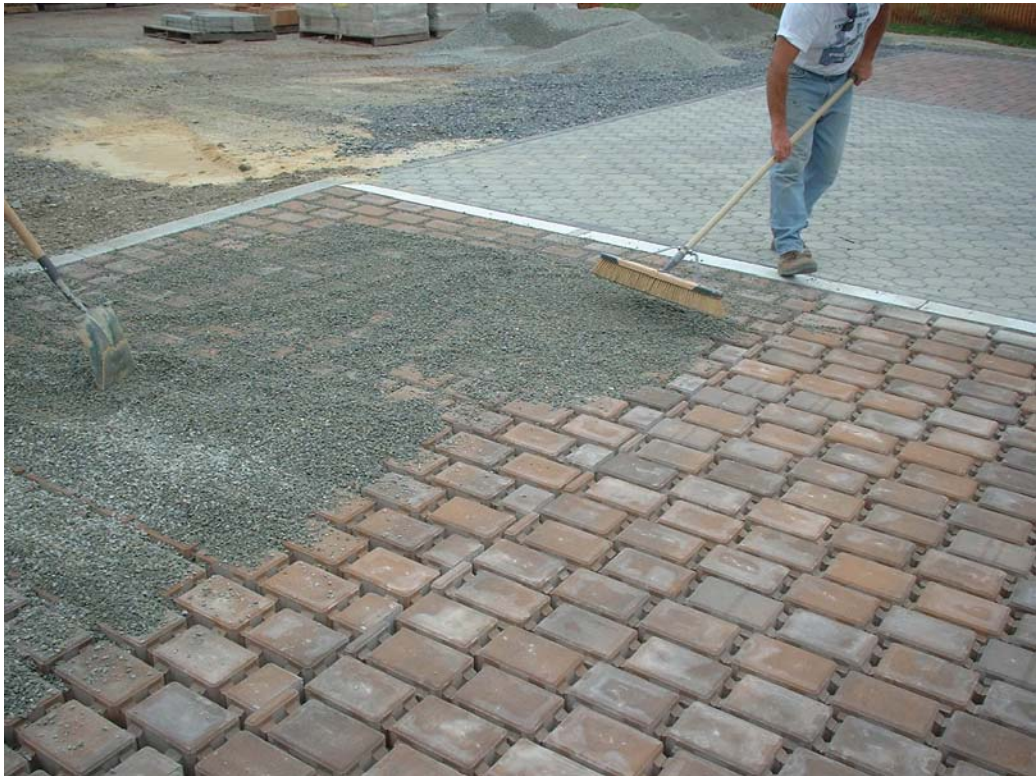
4

Pea gravel
placement
between Eco
Paver units

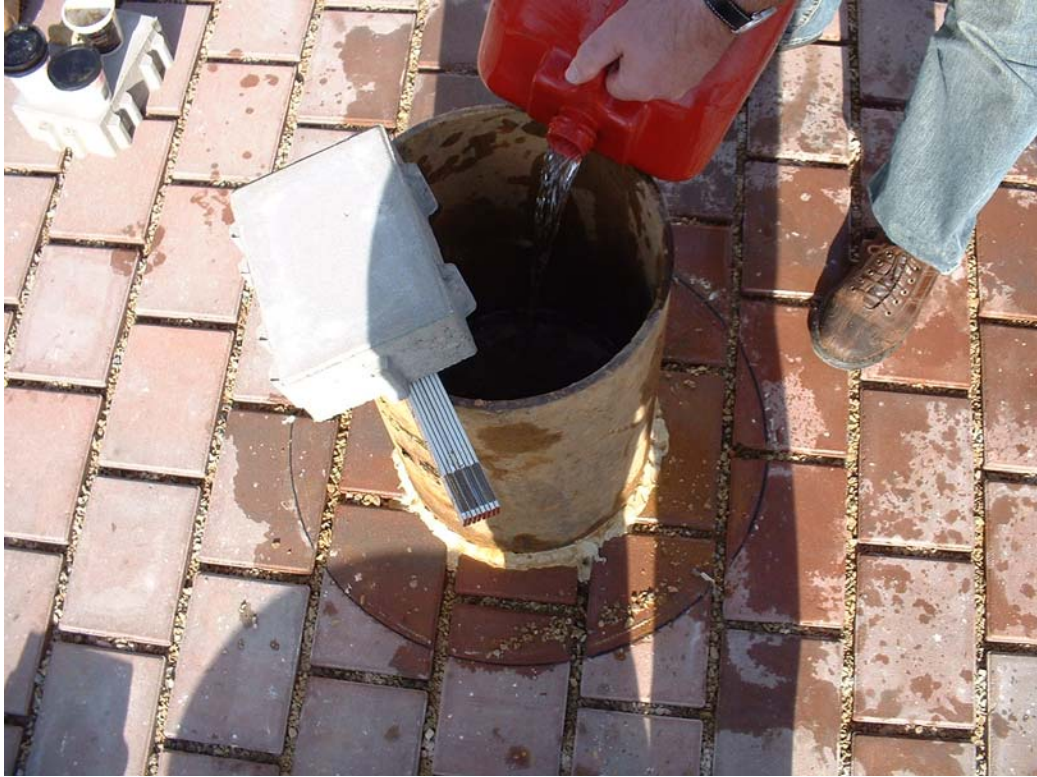
5

Single-ring
placement
for surface
inundation
test

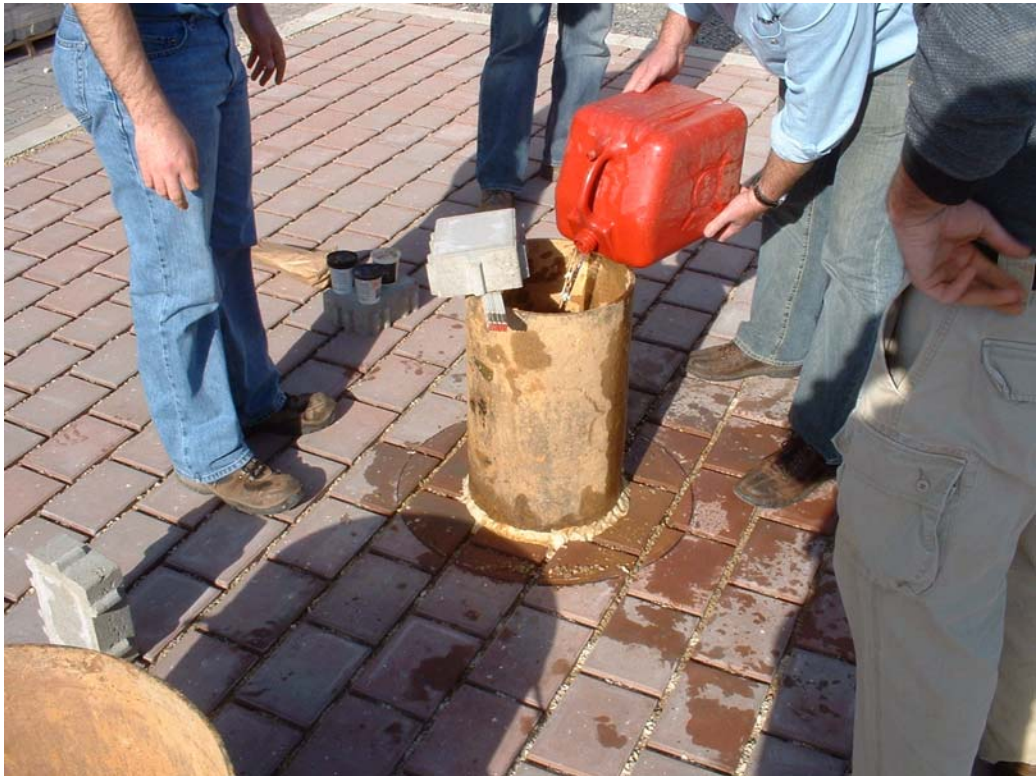
6

Surface
inundation
test
